# Upper Columbia Salmon Recovery Region Indicators

**Upper Columbia  
Salmon Recovery  
Region**

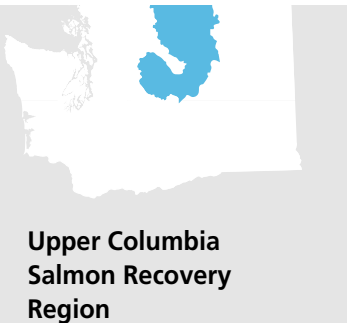
### Wolf Creek Fish Screen

Specialists from the Yakima Screen Shop replaced an old fish screen that did not meet state or federal standards and was harming fish.

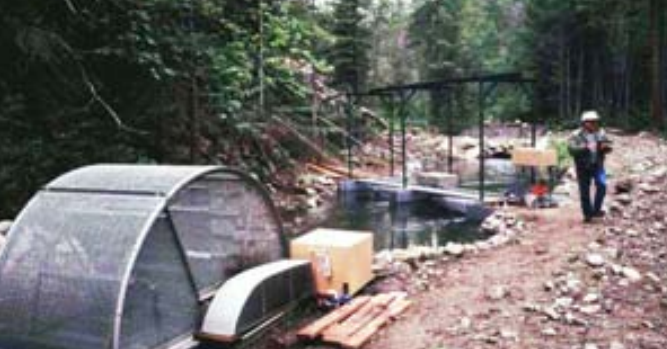
The Yakima Screen Shop designed, built, and installed a screen and by-pass system that will allow steelhead, Chinook, and bull trout to move along this tributary to the Methow River.

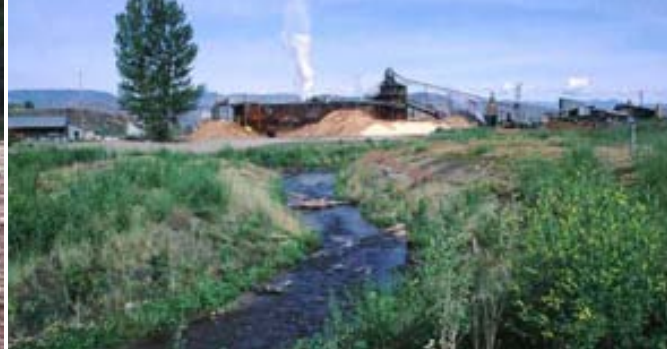
### Omak Creek Restoration

The Colville Tribe, working with local timber mill owners, restored a section of Omak Creek to improve riparian habitat and reduce bank erosion.

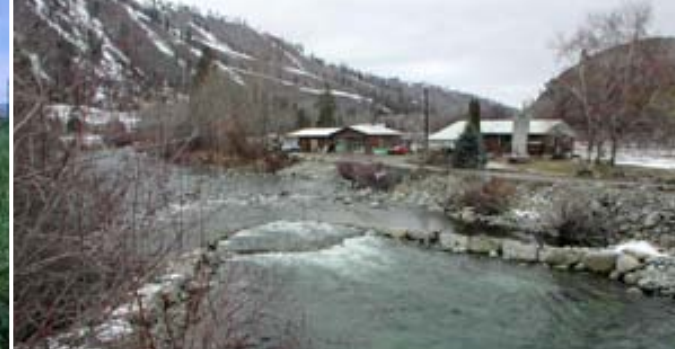
### Entiat River Rock Vortex Weirs

Landowners, working with the Chelan County Conservation District, placed these structures in the Entiat River as part of a plan to restore the river.

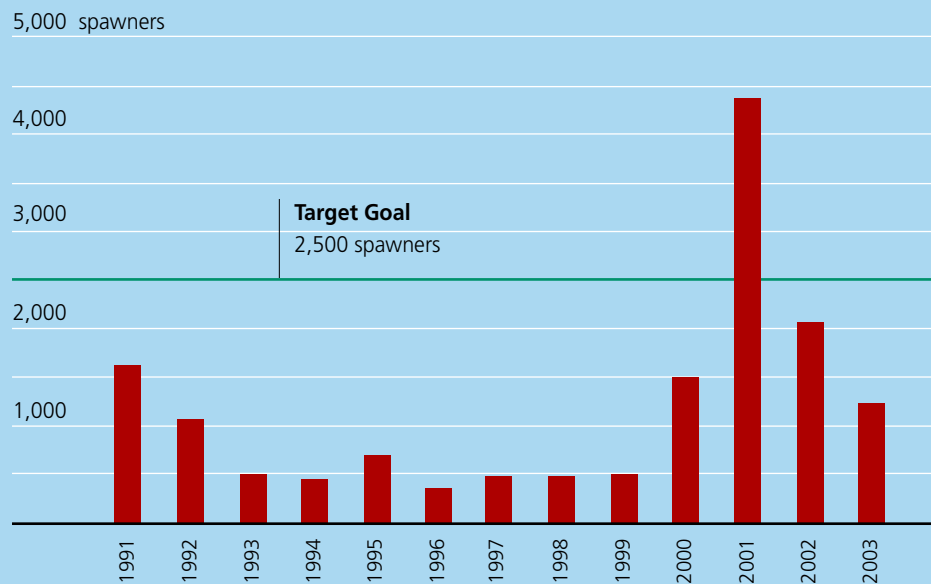
## Upper Columbia River Wild Steelhead

- ▶ Spawner abundance for 1 of 3 populations.
- ▶ Target Goal from NOAA-Fisheries.

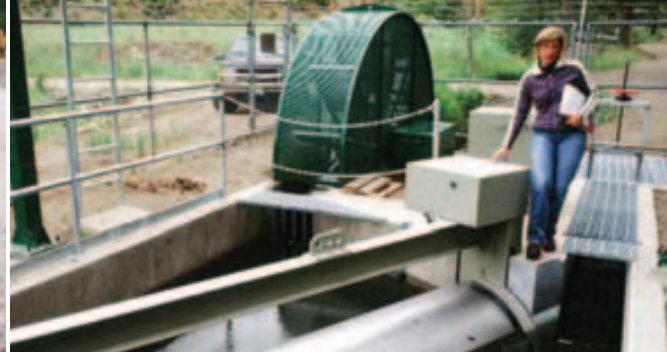
### Twisp Power Ditch Fish Screen

This new screen replaces an old one that was causing problems for juvenile Chinook, steelhead, and bull trout on the Twisp River.

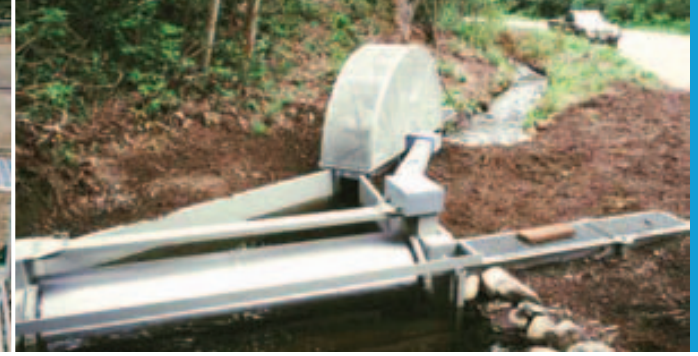
### Beaver Creek Watershed Fish Passage

Three new fish screens are being installed to replace inadequately or unscreened diversions on Beaver Creek, helping steelhead, Chinook, and bull trout.

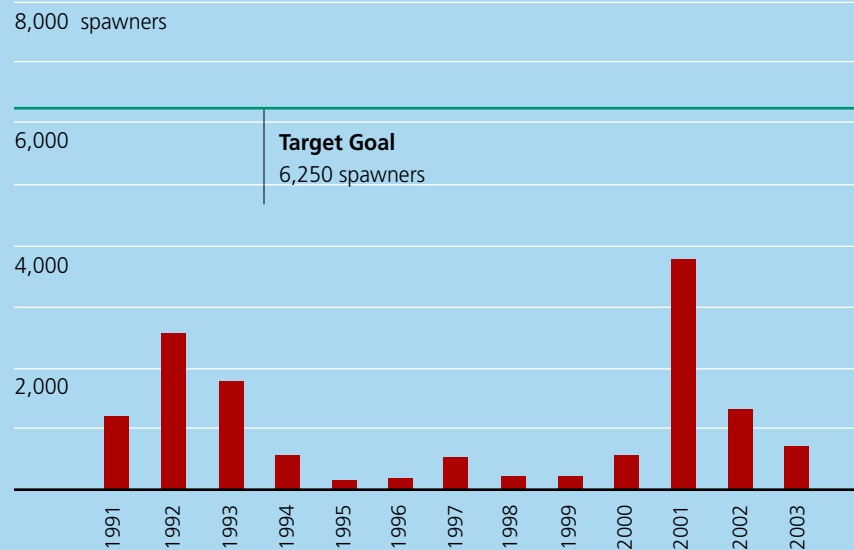
## Upper Columbia River Wild Spring Chinook

- ▶ Composite spawner abundance and target goal for 3 of 12 populations.
- ▶ Target Goal from NOAA-Fisheries
